International Journal of Engineering Research and Science & Technology

REPAIR AND REHABILITATION OF DISTRESSED STRUCTURES INCLUDING INDIAN CASE STUDIES DUE TO DETERIORATION OF CONCRETE AND STEEL CAUSED BY ENVIRONMENTAL AND OTHER FACTORS

Subhendu Das^{1*}

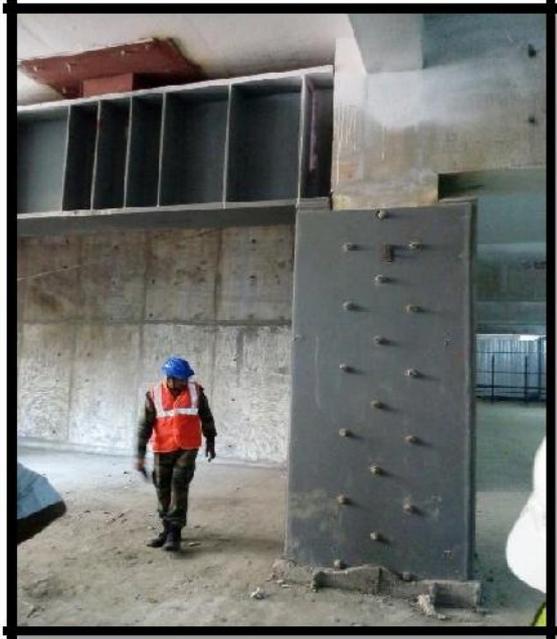
Figure 14: Steel Jacketing of Beam and Column at Trump Tower, Mumbai

requirements during the construction phase itself, which requires additional loads to be borne by the constructed columns not designed for such loads. Steel jacketing of such columns enhances their capacity as has been the case of Super high rise building of Trump Tower presently under construction in Mumbai.

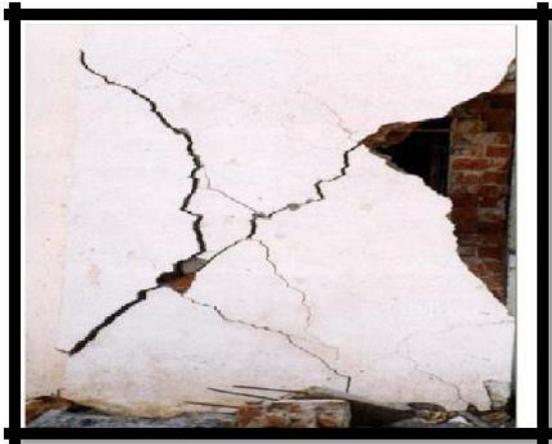
- Cracking/spalling of concrete in sunshades, staircases and beams.
- Reinforcement exposed/corroded heavily in some places.
- Severe seepage in roof slabs and external walls.
- De-lamination in waist slab of staircase and soffit of beams.
- No settlement in foundation.

Figure 15: Visible Spalling of Concrete

- Excessive chloride content found in the concrete.
- High humidity and hot climate aided deterioration in the concrete.
- High Carbon di oxide and other pollutants in the environment.
- Quality of cover concrete was found inadequate.

- Dismantling of sunshades and walls on the balcony, staircases and damaged beams and replacement with Prefabricated Light weight bricks.
- Fresh concreting replacing damaged concrete applying epoxy based bonding material at the junctions (Temporary supports provided during replacement).
- Cracks in the RCC pressure grouted with Epoxy based material.

- Spalled concrete repaired with polymer based mortar/concrete after applying epoxy bond coat.
- Complete surface coating with cement based paint with polymer compound.

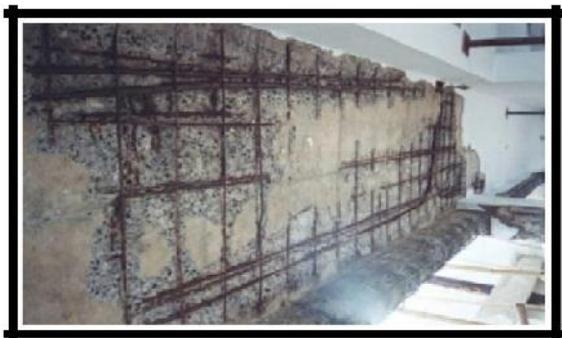
Figure 16: Corrosion of Exposed Reinforcement

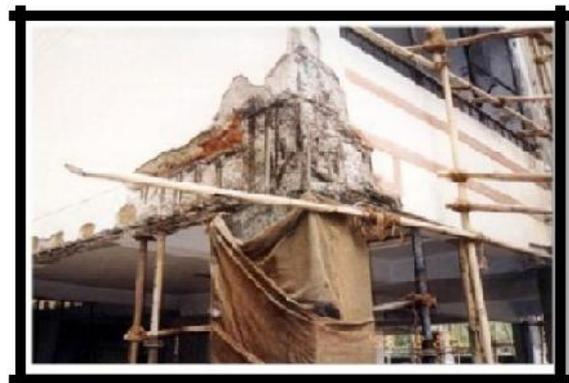
Figure 17: Corrosion of Rebars at Joints

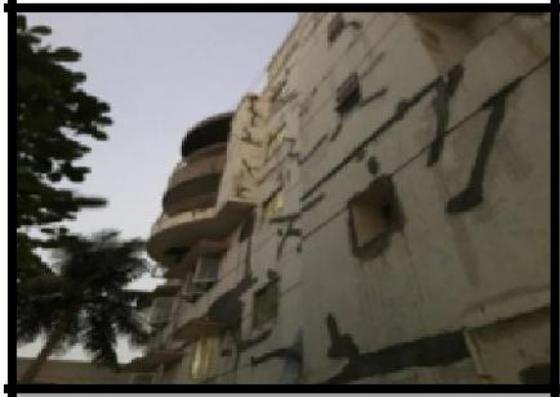
Figure 18: Repair of External Cracks with Polymer Modified Mortar

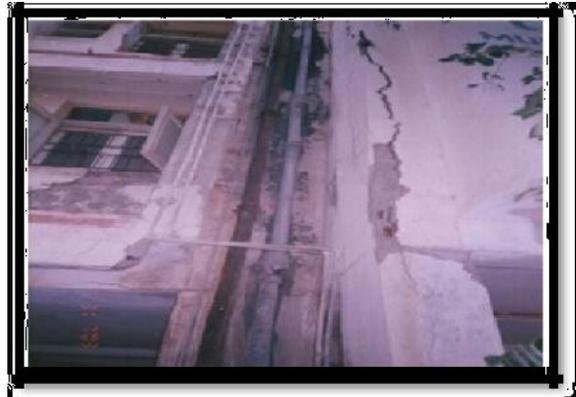
- Vertical cracks in columns along line of concrete cover.
- Cracks in masonry walls at Ground floor.
- Spalling of concrete in beams, columns, slabs and fins.

Figure 19: Vertical Cracks Along Concrete Cover Line

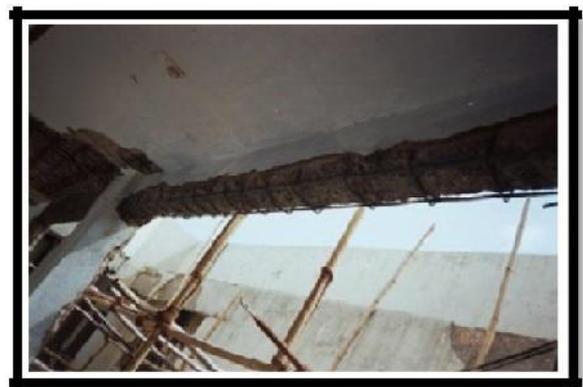
- Stirrups exposed and severely corroded at various places.
- No settlement in foundation.

Figure 20: Corrossion of Stirrups

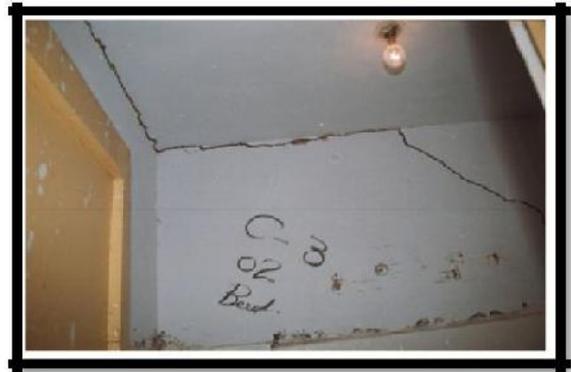
- The building was planned for M20 concrete however lower compressive strength assessed at various places.
- Earthquake resulted in further cracks and deterioration to the structure.
- Inconsistency in concrete quality indicated poor quality control during construction.
- High values of Carbonation depth indicated substantial corrosion attributed to carbonation.
- Earthquake resulted in further cracks and deterioration to the structure.

Figure 21: Cracks After Earthquake

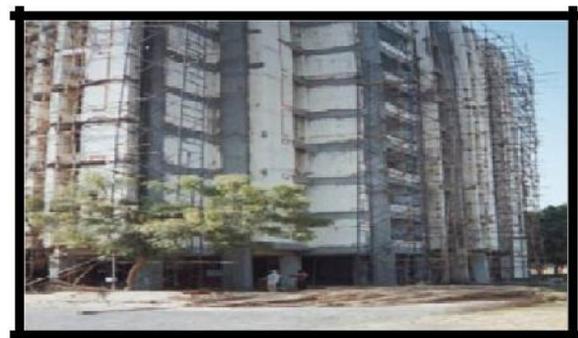
Figure 22: Repair with Polymer Modified Mortar

- Removal of visible spalled concrete in excess of 25 mm from the edges.
- Rust remover applied on the exposed rebars and wire brushed after 24 hours.
- Wherever steel cross section reduced over 20% due to corrosion, new reinforcement welded on both sides.
- As stirrups were considerably corroded, new stirrups were welded in 'U' shape.
- Cement and Acrylic Polymer slurry in 1:1 ratio, mixed with water used as Bonding Coat.
- The trial mix of Polymer Modified Mortar based as per CBRI, Roorkee guidelines and

approved design mix were: Cement 50 Kg: Sand (Zone II) 150 Kg:Acrylic Polymer 10-12 Kg and water in W/C ratio <math><0.4</math>.

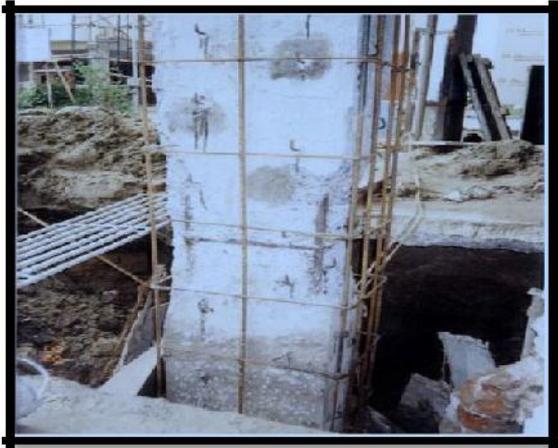
Figure 23: Concrete Jacketing

- Concrete Column Jacketing with Micro-concrete (RMC) of 75 mm thickness (Aggregate 6-10 mm, W/C ratio 0.21, Compressive strength 30 Mpi).
- Masonary wall cracks addressed with SBR Polymer grout.
- RCC elements and joints cracks addressed with Epoxy grout from Araldite (100 g GY257, 21 g Aradur 21 and 4 g Aradur 2958).

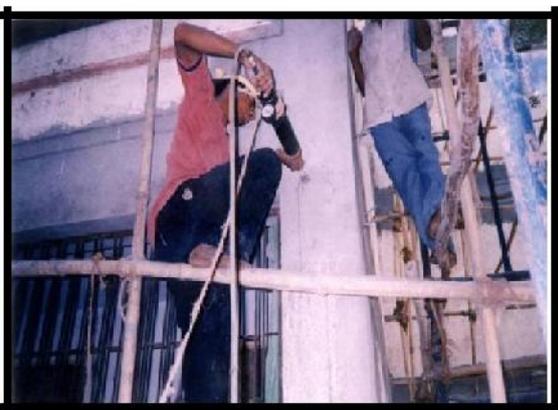
Figure 24: Epoxy Grouting

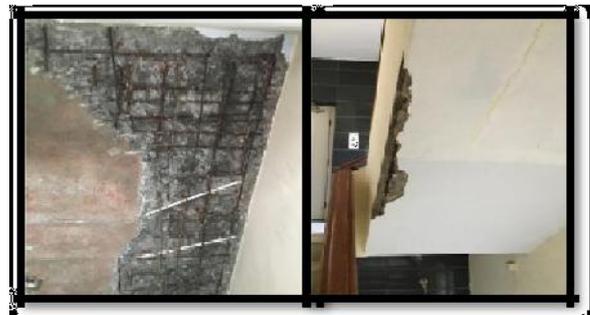
- Proximity to sea shore and exposure to saline environment aided deterioration.
- No prior treatment of reinforcement bars.

Figure 25: Spalling and Corrosion

- Quality of concrete tested and found satisfactory except high chloride content.
- Chloride penetration was considerable and removal of entire affected concrete was not feasible.

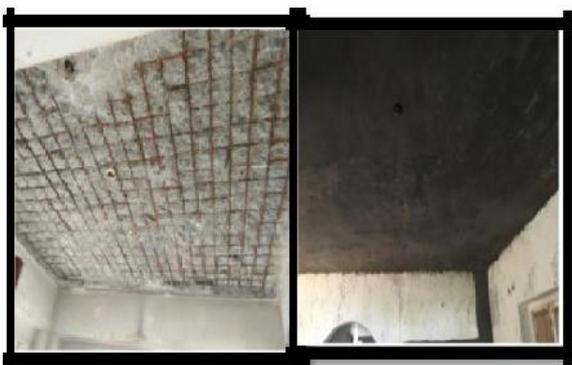
Figure 26: Application of PMM on Roof

- Similar to previous case studies.
- Use of Polymer Modified Mortar for replacing spalled concrete.
- Rust removal, treating and welding of new rebars as required.
- Epoxy pressure grouting.
- Concrete jacketing of affected columns.
- Surface sealing.
- In addition to the above two new methods were adopted during the rehabilitation; GFRP protection for the columns and Cathodic protection for the rebars.
- Glass Fibre Reinforced Polymer (GFRP) uniaxial sheets were wrapped around the affected columns after concrete jacketing to improve ductility and energy absorption capacity. The columns were finished with sand pellet layering.

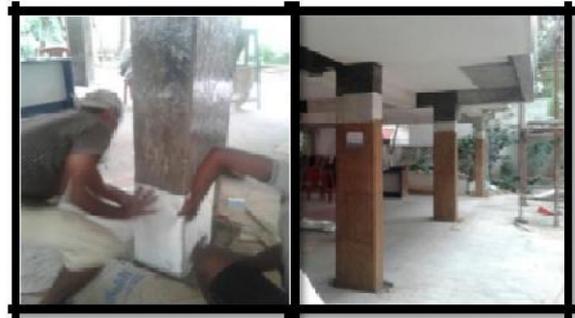
Figure 27: GFRP Wrapping of Columns

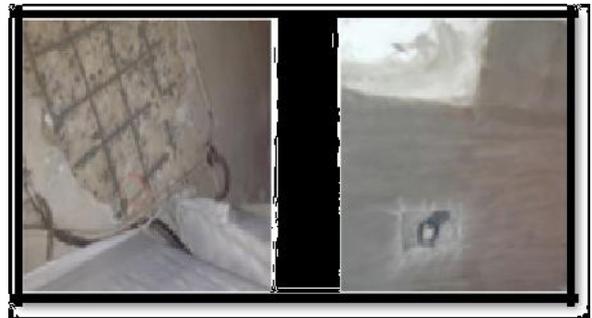
Figure 28: Sacrificial Zinc Anode

- As chloride penetration was considerable, the protection to rebars against corrosion was provided by provisioning of sacrificial Zinc anodes.
