**International Journal of
Engineering Research and Science & Technology**

A DESIGN AND ANALYSIS OF GAS TURBINE BLADE PROFILES USING DIFFERENT MATERIALS

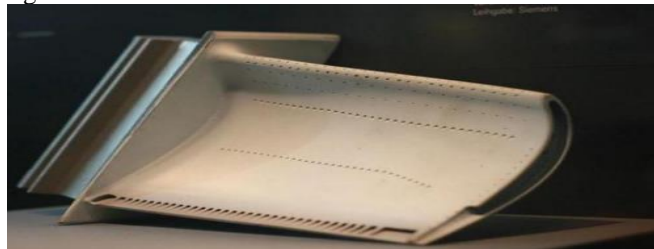
Turbine blades in gas turbines or steam turbines are made up of many smaller parts. The blades are what actually collect energy from the superheated, super pressed gas that the combustor produces. In order to function reliably in such extreme conditions, gas turbines frequently require exotic materials like superalloys and a wide variety of cooling technologies. These may be broken down into internal and external cooling, as well as thermal barrier coatings on the blades individually. For both steam and gas turbines, blade fatigue is a common cause of failure.

Figure 2: Turbine Blade

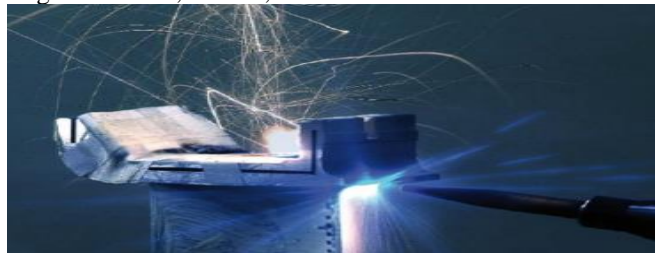
Figure 5: Turbine blade during laser drilling

The Laser systems for these deep penetration boxes (up to 25 mm) with pulse length are worked in the 1 mm range for these cylindrical holes at 15–90 °C on curved blade surfaces. Moreover, most of the exit holes are created so as to allow the film to cool down.

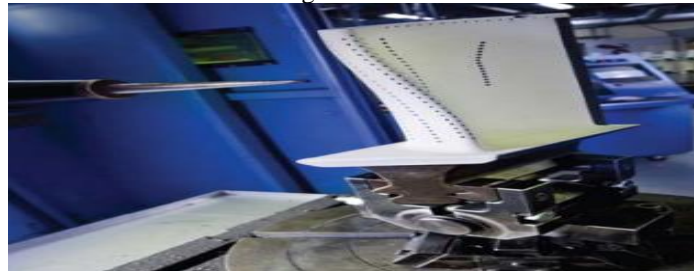
The number of cooling holes in turbine motors has risen considerably with the increased developments in laser process and control technology. Laser piercing enables the machining in a wide variety of materials in both very small and precise hole sizes and directions. These holes may be tapered or formed to improve the quantity, direction and cooling properties of the blade. One element with one setup can drill hundreds or thousands of cooling holes.

Figure 6: Laser drilling turbine blade

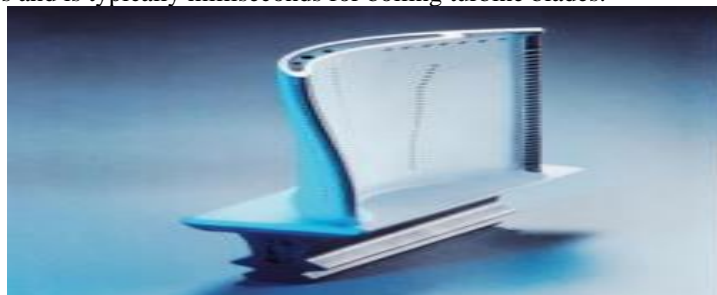
Melting and vaporising the material because of the absorption of energy from a concentrated laser beam is how most laser drillers of 0.8 mm diameter 0.0 hole in a 5 mm gap in turbine engine components work. Laser boiling pulse systems, the pulse length of which is determined by the system's overall parameters and is typically milliseconds for boiling turbine blades.

Figure 7: Gas turbine blade with about cooling holes, half of which have shaped exit holes.

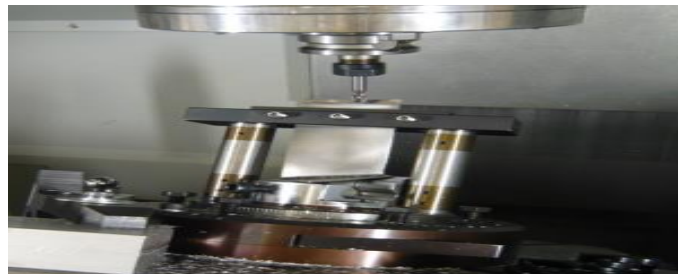
The advice proved flexible. The titanium thin-size wall geometry was CNC finished and blended using power MILL machining, which involved a highly cautious 500-1,500 mm/min feed speed with a spindle vessel of 2,000 rpm, and was performed without coolant or robust fixation utilizing the ball's nose cutting system. The milling exhibited short fills from the laser cladding (where not enough material was stored), but it helped resurface and return the blade to its desired form and tolerance otherwise.

Figure 8: Adaptive CNC blending of repaired air foil tip
